**THE STREAMBANK EROSION CONTROL
EVALUATION AND DEMONSTRATION ACT OF 1974
SECTION 32, PUBLIC LAW 93-251**

Appendix D - Ohio River Demonstration Projects

4. TITLE (and Subtitle) LITERATURE SURVEY AND PRELIMINARY EVALUATION OF STREAMBANK PROTECTION METHODS		5. TYPE OF REPORT & PERIOD COVERED Final report
6. AUTHOR(s) Malcolm P. Keown Elba A. Dardeau, Jr. Noel R. Oswalt Edward B. Perry		7. PERFORMING ORG. REPORT NUMBER

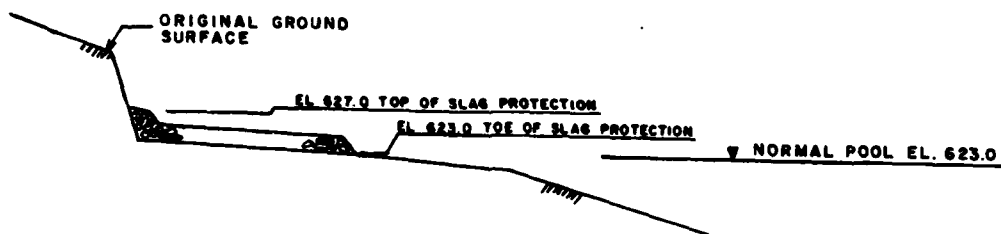
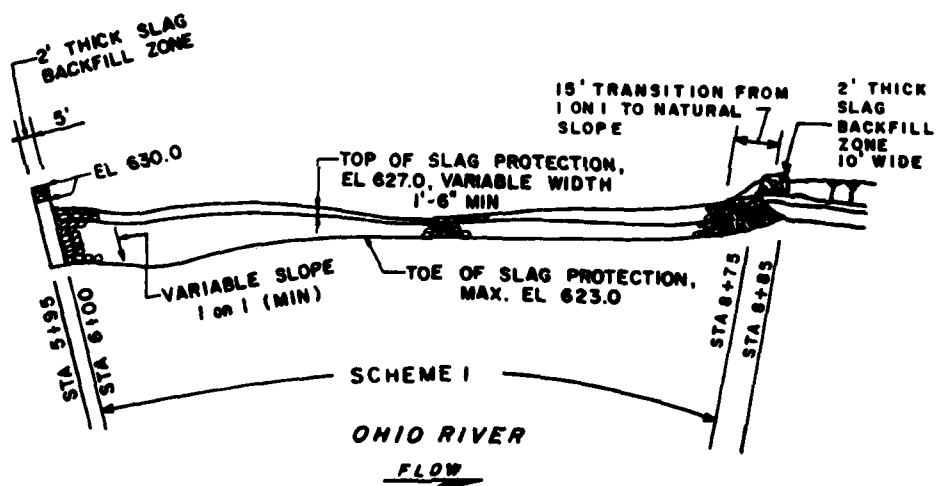
PLATE 12

1. Scheme 1. This 275-foot reach of protection was constructed by placing graded steel furnace slag along the existing ground surface from pool elevation 623.0 to elevation 627.0 with a minimum thickness of 18 inches and an outer slope no steeper than one vertical on one horizontal. The slag was well graded between two and 18 inches and was placed without a filter. There was no treatment of the bank above elevation 627.0. Scheme 1 details are shown on Plate 12.

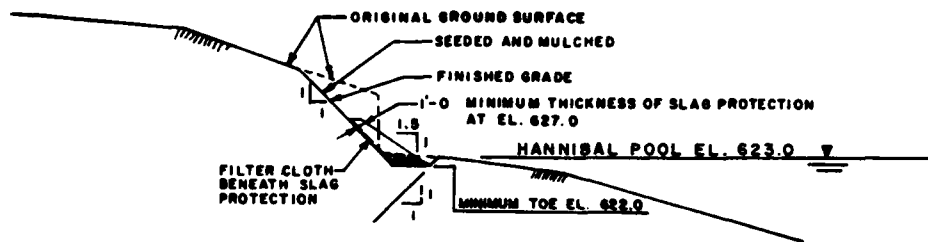
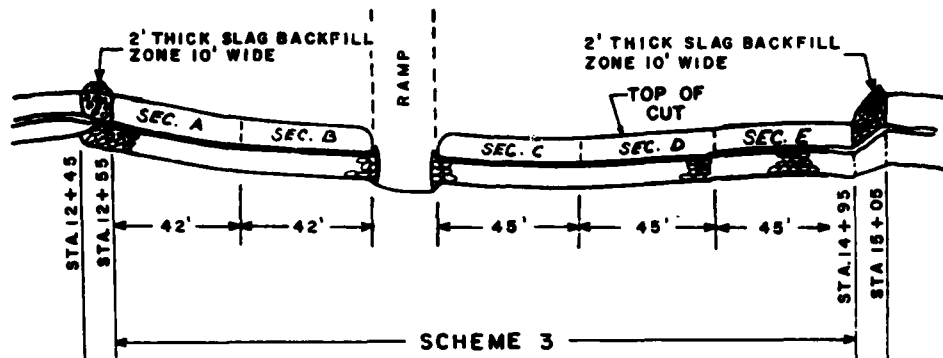
PLATE 14

below pool, to the top of bank, and placing graded slag from elevation 622.0 to elevation 627.0. The slag was placed atop filter fabric and with an outer slope of one vertical on one and one-half horizontal. The bank above elevation 627.0 was seeded and mulched. Plate 14 shows details of Scheme 3.

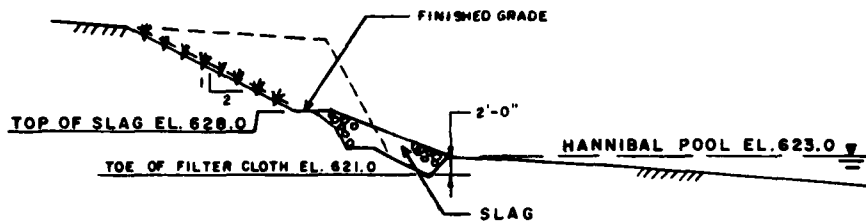
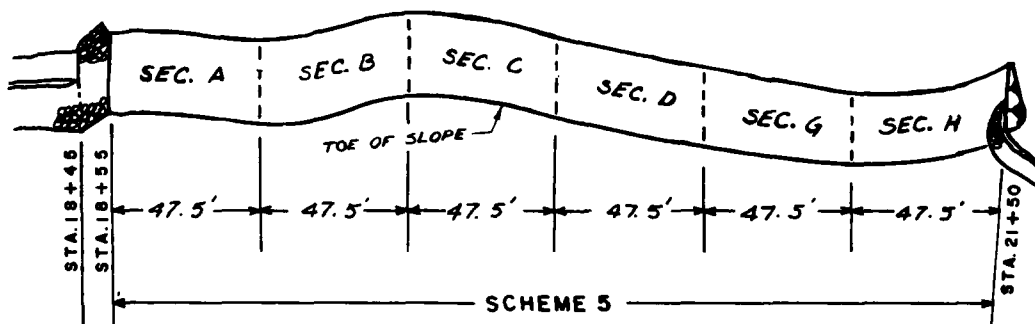
PLATE 16

5. Scheme 5. This 300-foot long scheme was constructed by grading the bank to a one vertical on two horizontal slope, placing a 12-inch thick blanket of graded slag from elevation 623.0 to elevation 628.0 atop filter fabric, and planting the upper bank with a variety of shrubs. Plate 16 shows details of Scheme 5.

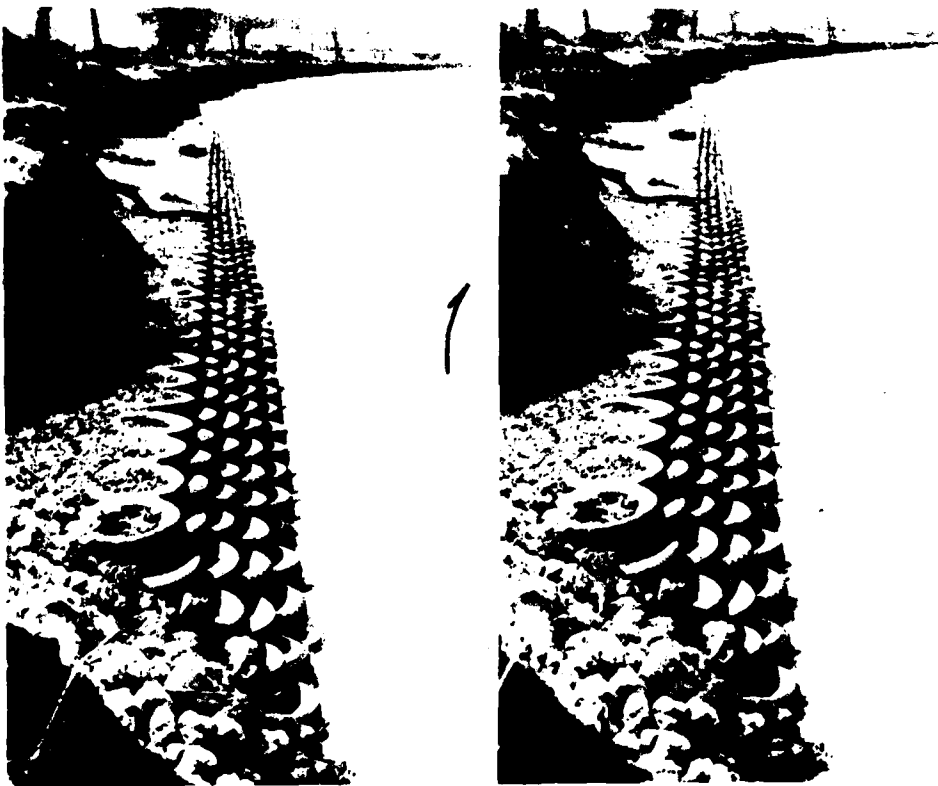
PLATE 26

several occasions since construction segments of the wall, ranging in size from two to twenty tires, have been laboriously dismantled. District employees repaired some early damage, but, the vandalism has outgrown any reasonable hired labor repair effort. Plate 24 shows typical vandalism of the rubber tire wall. The top row of tires was filled with concrete soon after construction to discourage vandals, however, this proved inadequate. At the conclusion of the monitoring period, the District will repair the damages and seek some means to protect the wall from further abuse. The upper bank has stabilized well, even though the plant performance has not been good. The two most successful plants, silky dogwood and arrowood viburnum, are rated in fair condition. The companion grass (tall fescue) seeded among the plants to provide immediate erosion control has been very vigorous and has effectively stabilized the upper bank. The performance of all the vegetal features of the project is summarized on Plate 25. Photos of Scheme 2 are shown on Plates 26, 27 and 28.

DURING CONSTRUCTION
TAKEN FROM STATION
8+75
16 MARCH 1978

STEREOSCOPIC VIEW TAKEN FROM
STATION 8+80 DURING CONSTRUCTION
29 MARCH 1978

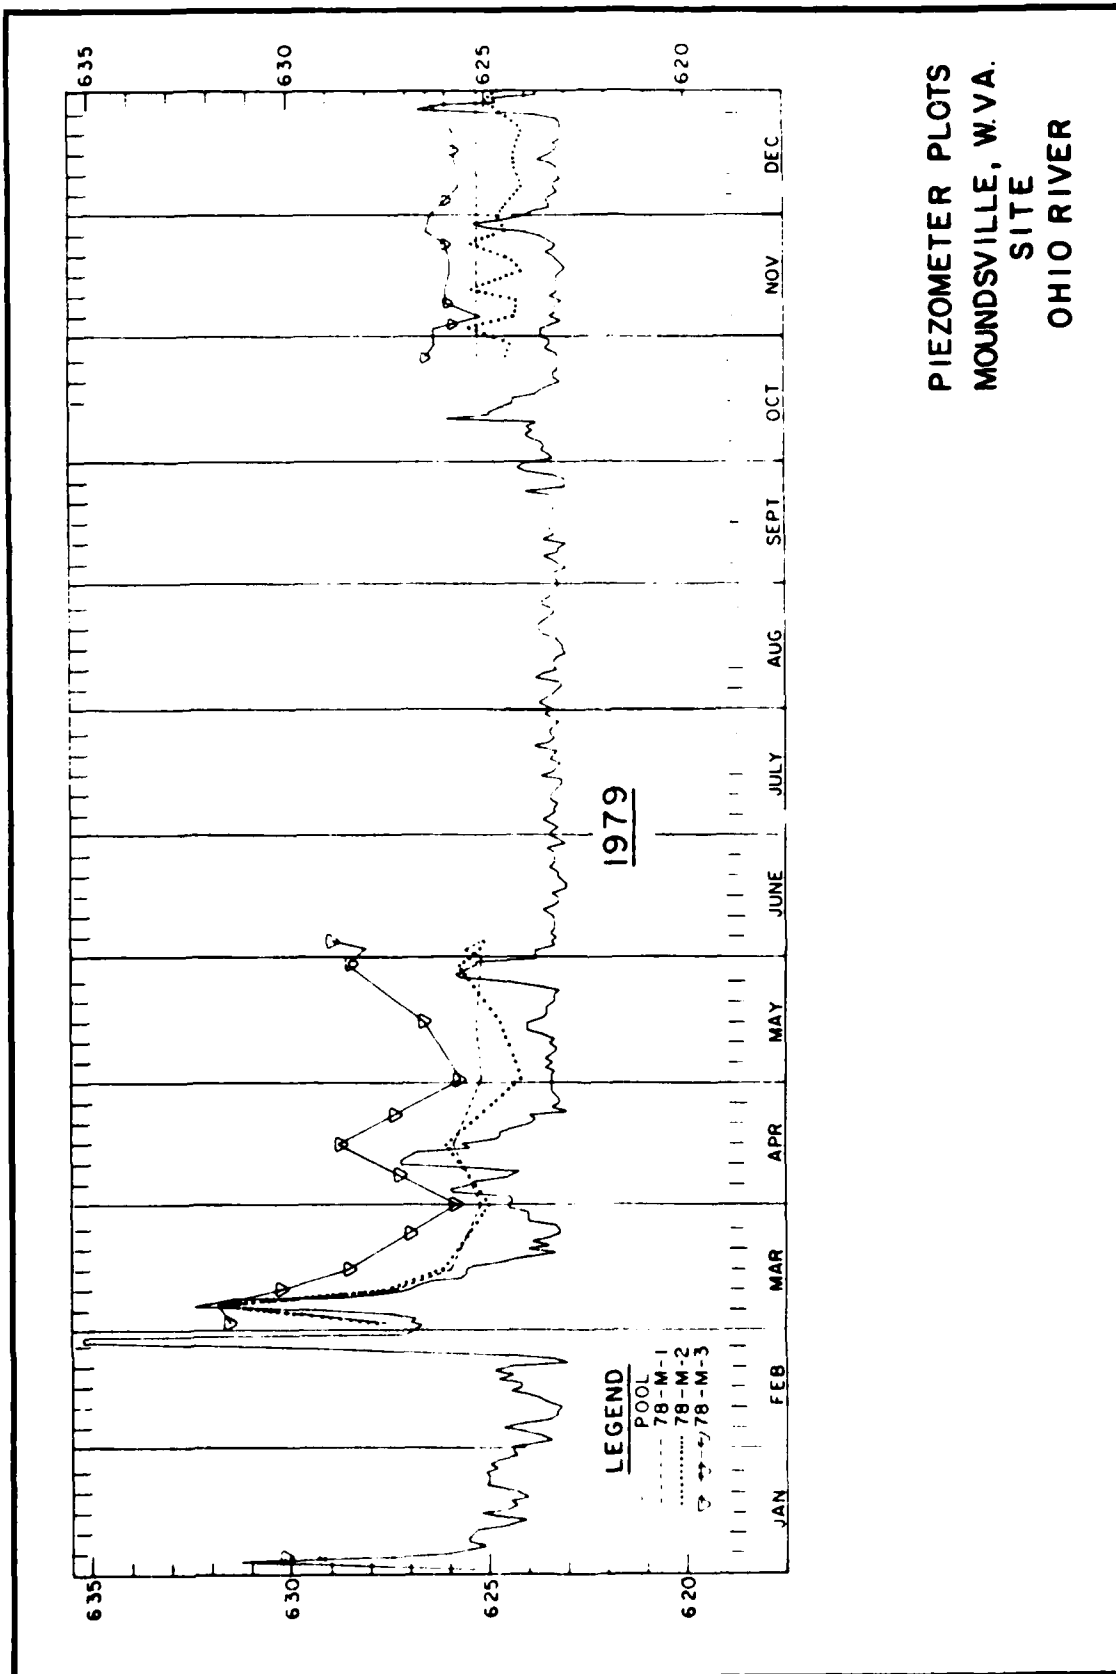
PLATE 10

3. Riverbank Description. The riverbank at the demonstraton site is composed of fine grained alluvium deposited by past flood events in a thinly interbedded structure of fine sands, silts, and clays. Plate 10 shows the logs of the boring made for the installation of piezometers. The landward area is planted with grass and is mowed to within several feet of the top of bank. A few mature trees grow near the top of bank along the demonstration reach.

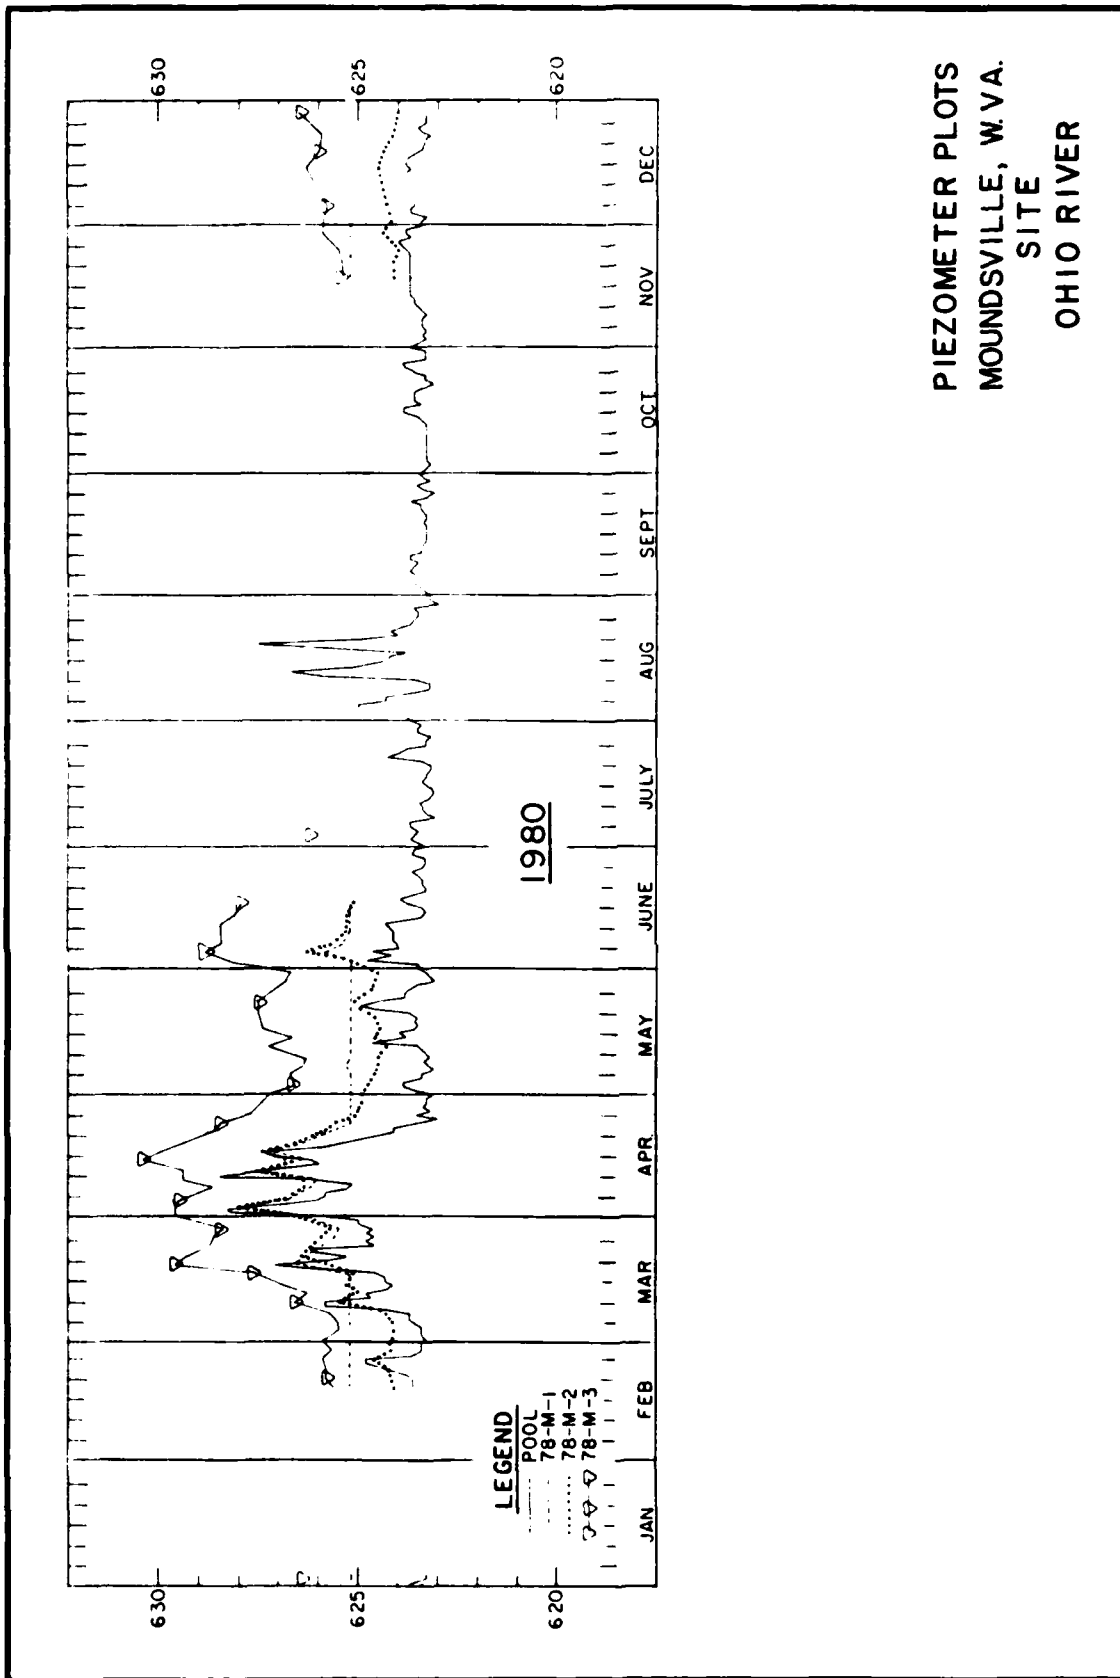
PLATE 11

Piezometers were installed at the demonstration site and monitored twice per week. Plate 9 shows the piezometer locations and Plates 10 and 11 are plots of the piezometric levels and the river stage. Wave action was observed visually under various wind and traffic conditions. The maximum observed wave height was approximately one foot and was induced by traffic during low flow conditions. The minimum pool elevation is maintained at elevation 623 by the operation of Hannibal Locks and Dam, 20 miles downstream. Flows are controlled by eight gated bays, each 110 feet long, and a 110-foot long fixed weir section. The dam gates are raised to pass high flows, so that the influence of the dam on the river decreases with increasing flow. At the demonstration site the influence of the dam during floods is insignificant. Prior to the completion of the Hannibal Project in 1975 the river at the demonstration site was maintained at minimum pool elevation 610.5 by Lock and Dam 14. The operation of the wicket type dams is described in paragraph II.A.3.

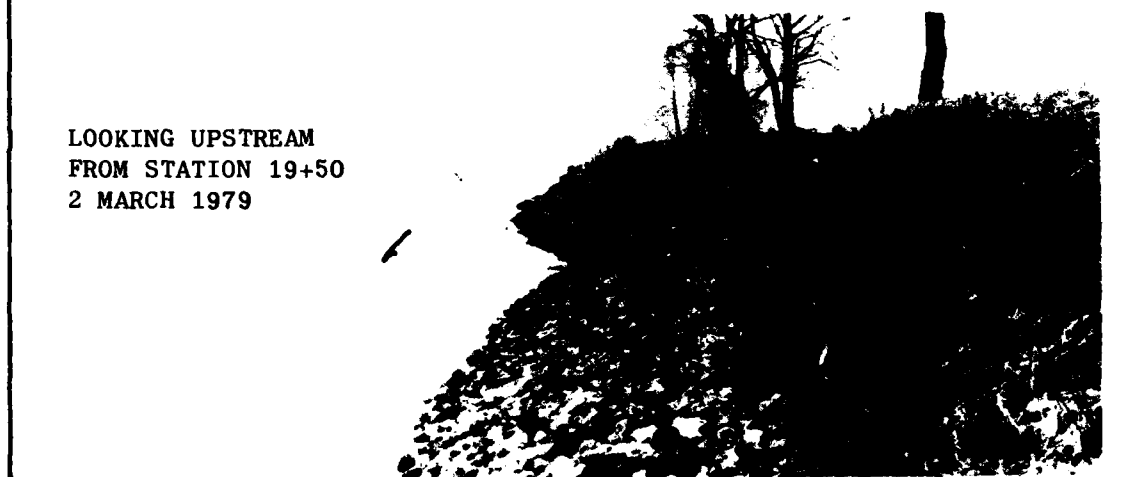
SCHEME 4 PHOTOS
MOUNDSVILLE, W. VA.
SITE
OHIO RIVER

LOOKING UPSTREAM
FROM STATION 19+50
24 MARCH 1978

LOOKING UPSTREAM
FROM STATION 19+50
2 MARCH 1979

LOOKING UPSTREAM
FROM STATION 19+50
3 DECEMBER 1980

drainage and sloughing of portions oversteepened by preproject lower bank erosion. The Scheme 4 upper bank, which extends from elevation 627, has suffered from all three high waters of early 1979. Although a local gas line was exposed in the process, the extent of erosion has been minor. Photos of Schemes 3 and 4 can be seen on Plates 22, 23, 24, and 25.

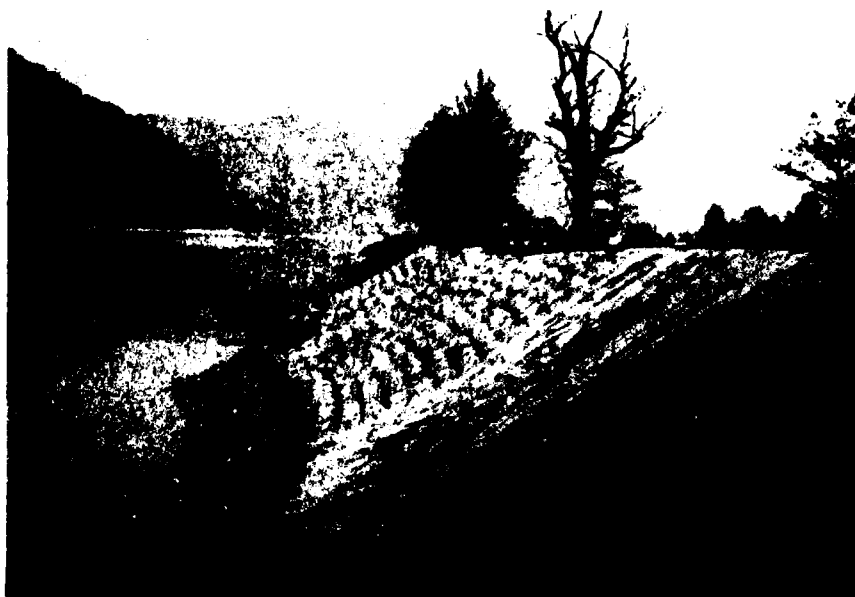
SCHEME 5 PHOTOS
MOUNDSVILLE, W. VA.
SITE
OHIO RIVER

6. Scheme 5. This scheme has been effective and, as in Scheme 4, has experienced some slag displacement due to scavenging for scrap. The most successful plant is the red osier dogwood. Photos of Scheme 5 are shown on Plates 35, 36 and 37.

PRECONSTRUCTION
17 APRIL 1974

LOOKING UPSTREAM FROM STATION 23+50
29 APRIL 1977

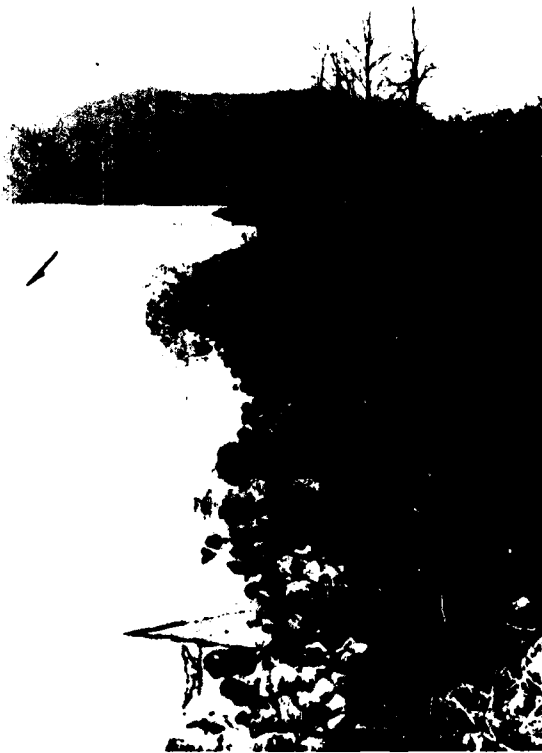
LOOKING UPSTREAM FROM
STATION 22+75
24 MARCH 1978

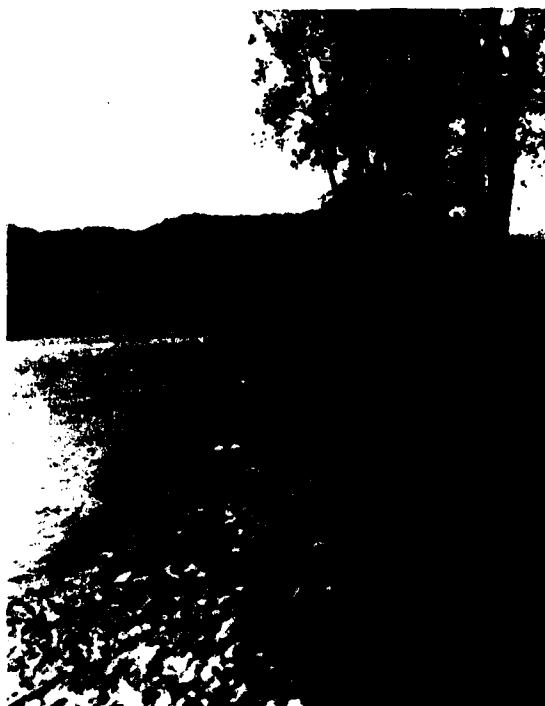
LOOKING UPSTREAM FROM
STATION 27+50
6 JUNE 1977

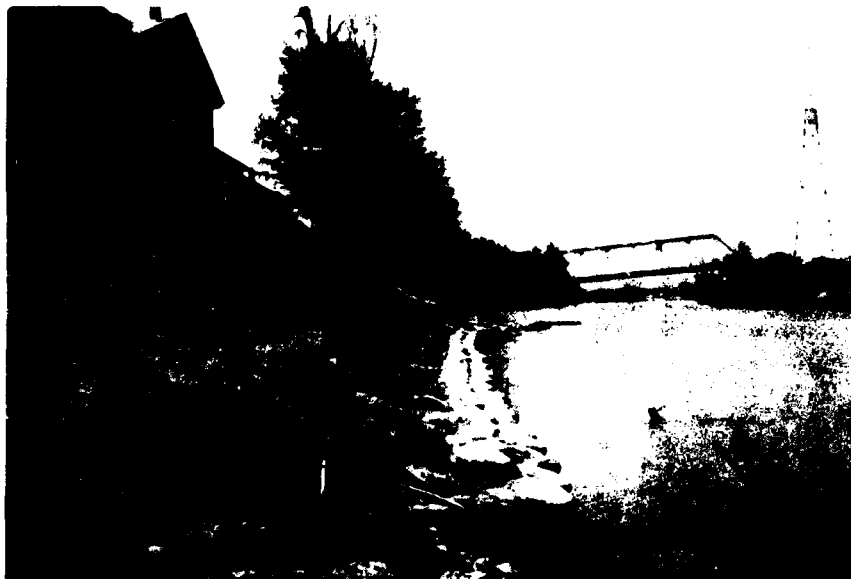
EXHIBIT II-7

SCHEME C: LOOKING UPSTREAM AFTER CONSTRUCTION

4. Scheme C. The quarry run rock and gravel do not evidence displacement or deterioration. The ungraded upper bank has continued to erode by piping, related slabbing, and drawdown initiated slumpages.

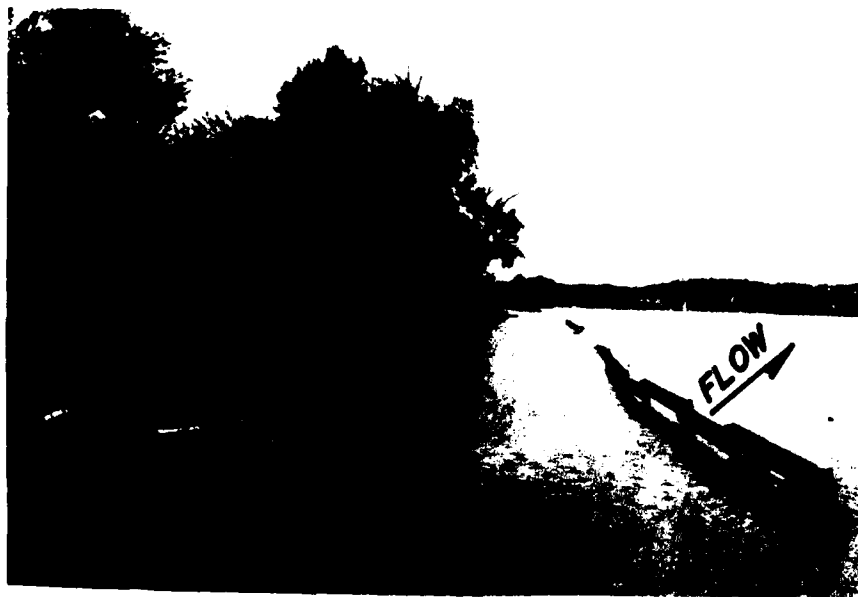
EXHIBIT II-2

SCHEME A: LOOKING DOWNSTREAM AFTER CONSTRUCTION

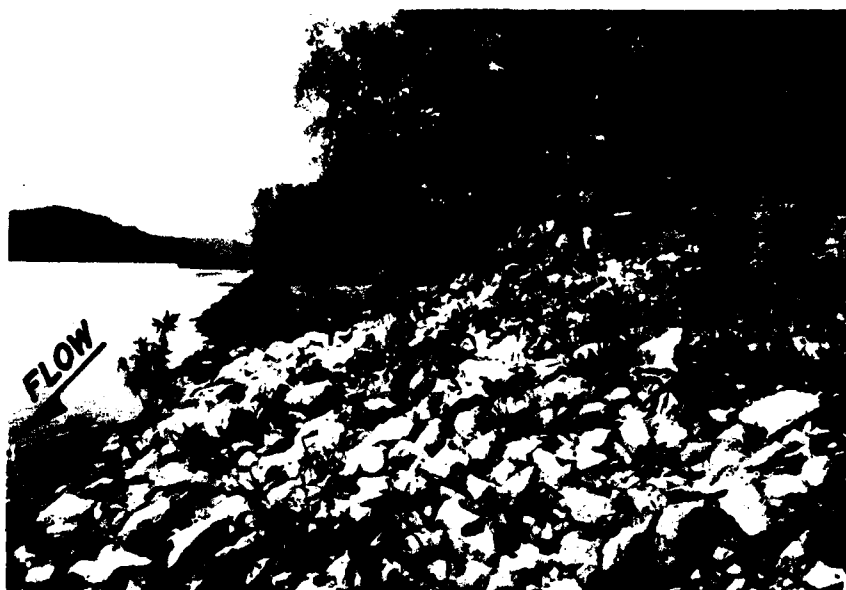
EXHIBIT II-4

SCHEME B: LOOKING UPSTREAM AFTER CONSTRUCTION

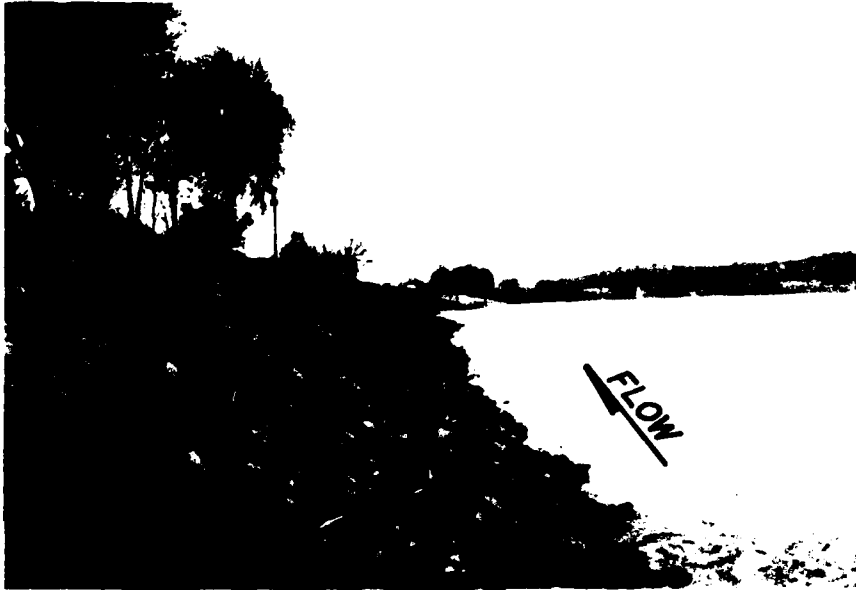
EXHIBIT II-6

SCHEME C: LOOKING DOWNSTREAM AFTER CONSTRUCTION

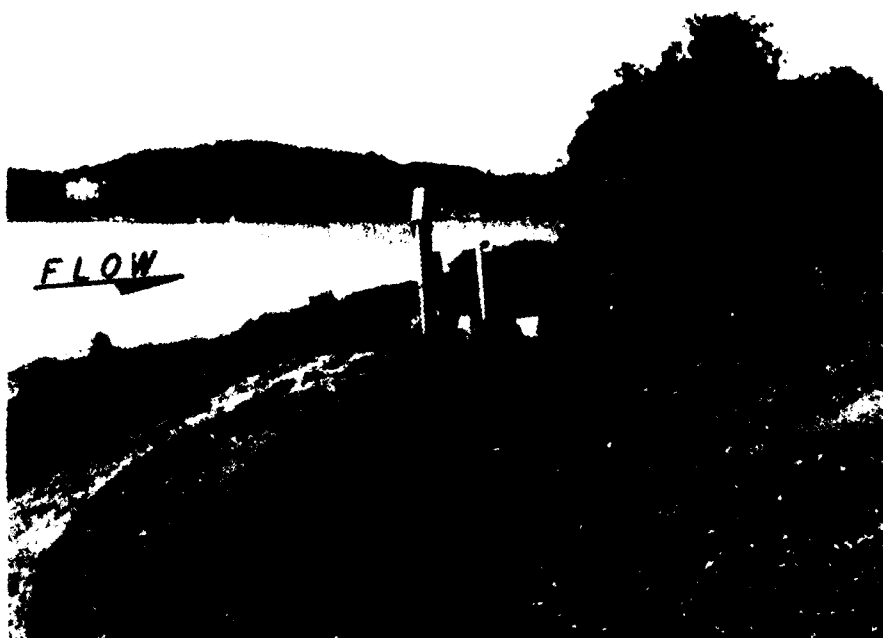
EXHIBIT II-1

SCHEME A: LOOKING DOWNSTREAM DURING CONSTRUCTION

The District has been aware of bank failure and erosion at this site since historical times and inclusive of the channelization period. Photographs submitted as Exhibit Nos. II-1 thru II-8 indicate the condition of the bank prior to construction, during construction, and after construction of the demonstration project.

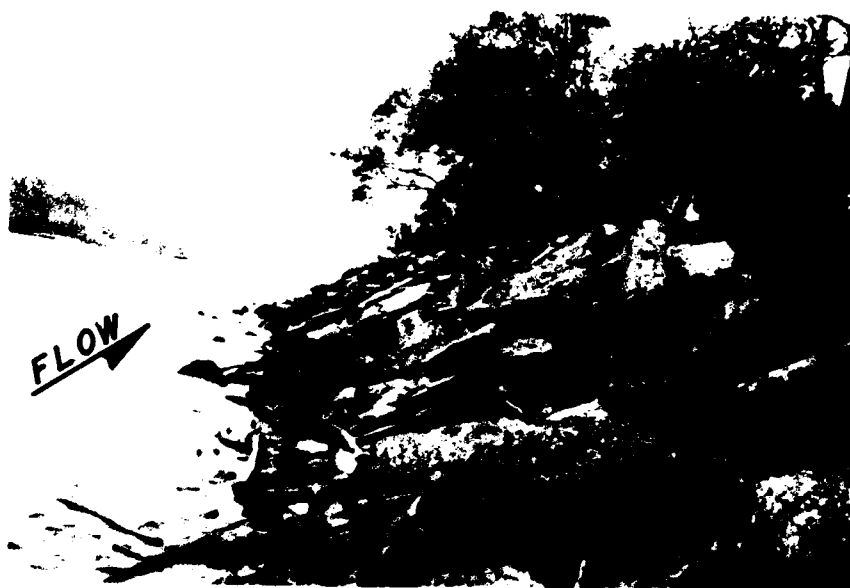
EXHIBIT II-2

SCHEME A: LOOKING DOWNSTREAM AFTER CONSTRUCTION

2. Scheme A and Scheme D. The waste rock and the slag show deterioration and limited downslope movements. Lower slope protection remain largely intact, however, upper bank piped openings and drawdown-related scarps of limited area extent have occurred during the post-construction period.

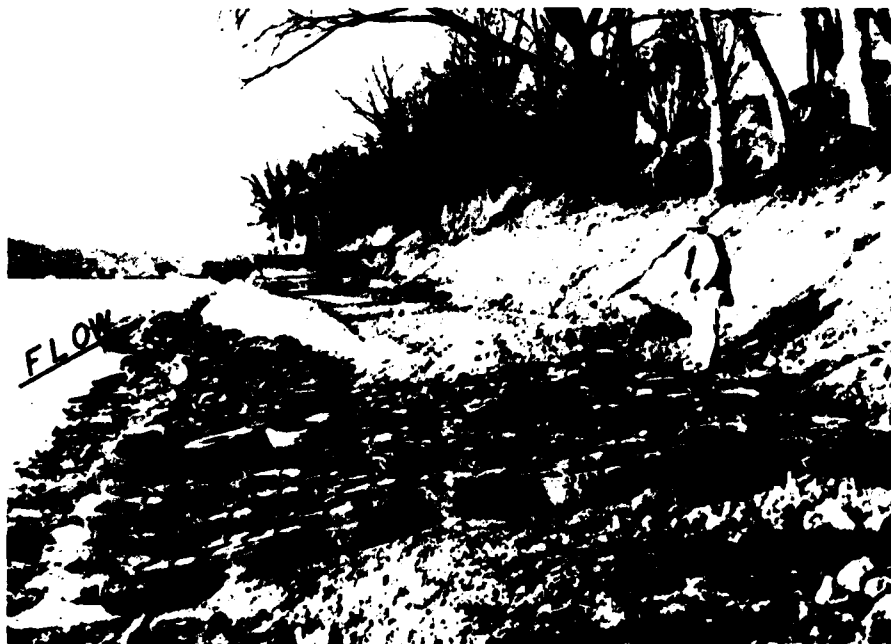
EXHIBIT II-3

SCHEME B: LOOKING DOWNSTREAM DURING CONSTRUCTION

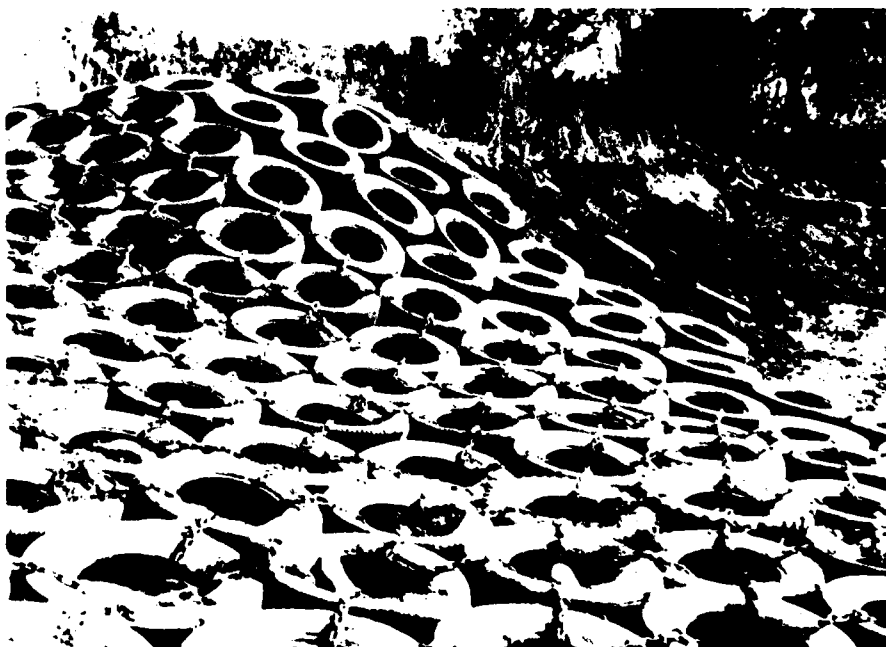
EXHIBIT II-5

SCHEME C: LOOKING UPSTREAM DURING CONSTRUCTION

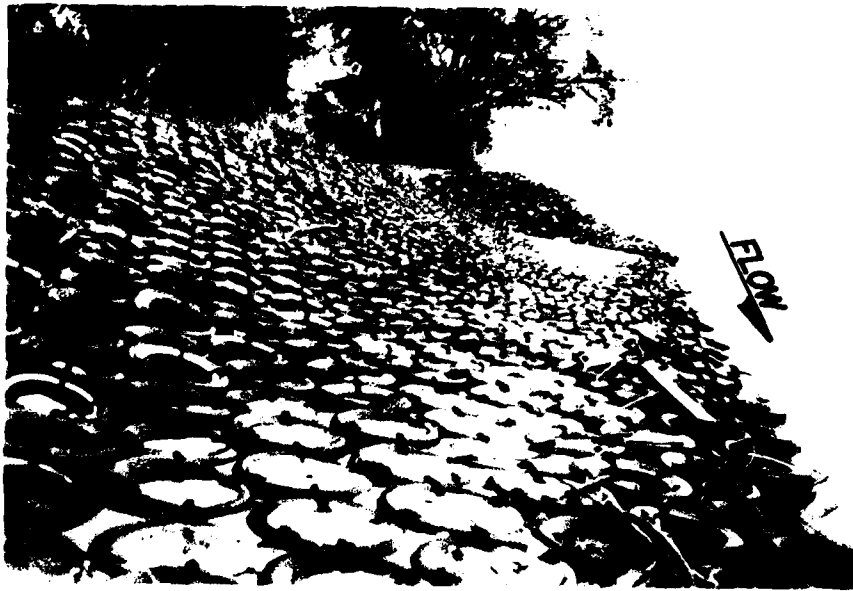
EXHIBIT II-6

SCHEME C: LOOKING UPSTREAM AFTER CONSTRUCTION

3. Scheme B and Scheme C. Reaches of the quarry run rock treatments have failed during storm and flood events and as a result of seasonally persistent seepages. The upper bank, which is largely dump debris, has continued to erode most often by piping and overland flows.

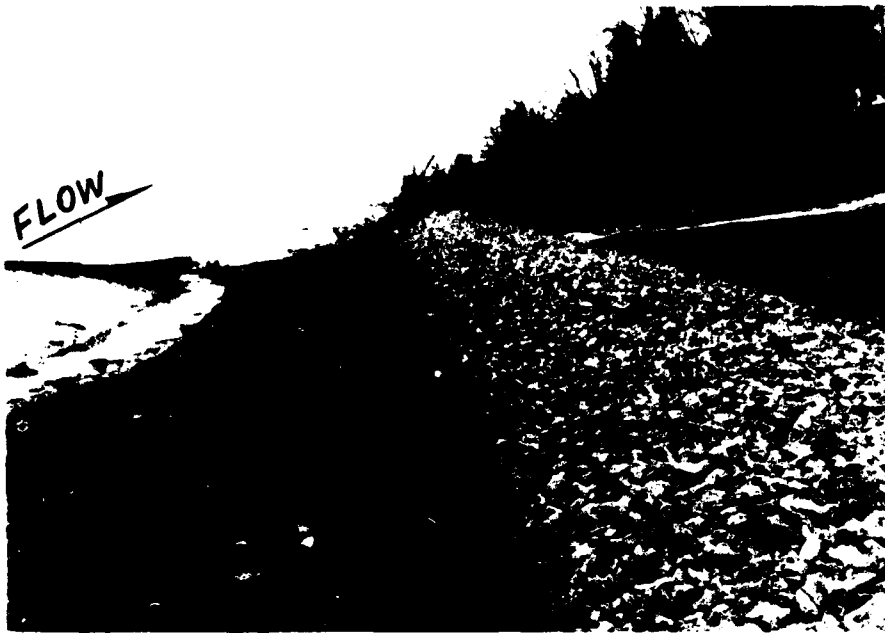
the relative gentle slope of the earth bank, vegetation will probably take hold and maintain bank stability. Future monitoring inspections will be required to verify this. Possible problem areas at the site could be at the upstream and downstream ends of the project and where the gradually sloping bank meets the steeper banks near the residences. The June 81 monitoring inspection showed some sloughing taking place along the base of the steeper upper bank near residences. This appeared to be caused by high water flows and by "piping" of water through sandy areas of the ground. Photo 7 is a typical example of this problem area. Photo 8 shows the upstream portion of project where "hold-grow," straw, and willows were washed out by high water. Overall stability of this area appears good nevertheless. Riprap toe all along project was in excellent condition.

PHOTO NO. 1. 22 Jan. 81. Second Monitoring inspection. Looking downstream (Stations 20+40-27+30).

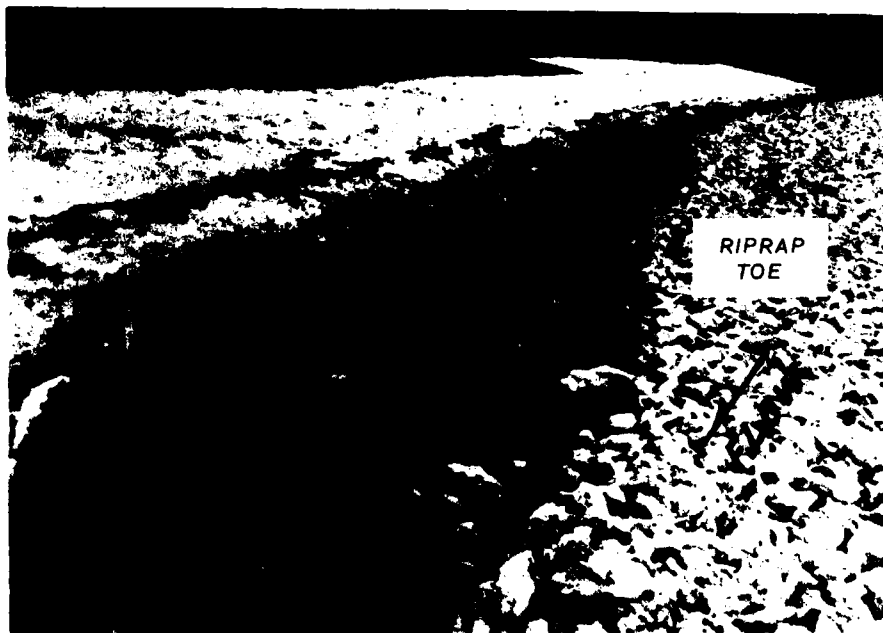
12. Evaluation of Protection Performance. By 22 January 1981, the project was complete except for seeding and willow tree planting. Photos 4 and 5 show "hold-grow" cloth and straw areas which river flow had damaged. They are not able to withstand river flow. During early June 81 high water, the "hold-grow" and straw were totally washed away. Also, some sloughing of the upper bank at downstream end of project had occurred during the June 81 high water. This water reached elevation 485 . Lower level areas actually had sediment deposits. All willow tree seedlings were either covered by sediment or washed away.

PHOTO NO. 4. 22 Jan. 81. Second Monitoring inspection. Closeup of "Hold Grow" mat--cannot withstand river current.

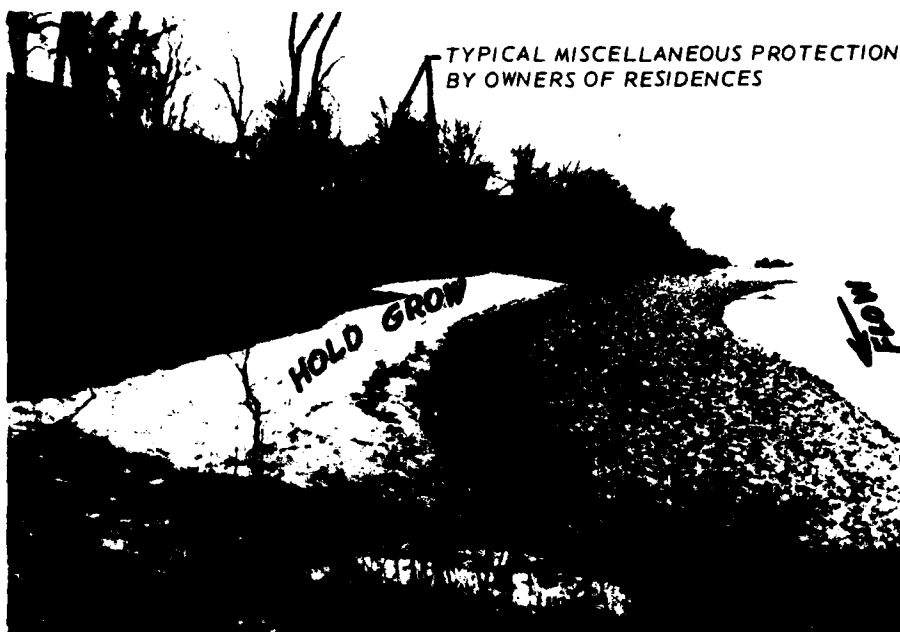
PHOTO NO. 5. 22 Jan. 81. Area upstream of cobblestone warf (Stations 10+80-16+50).

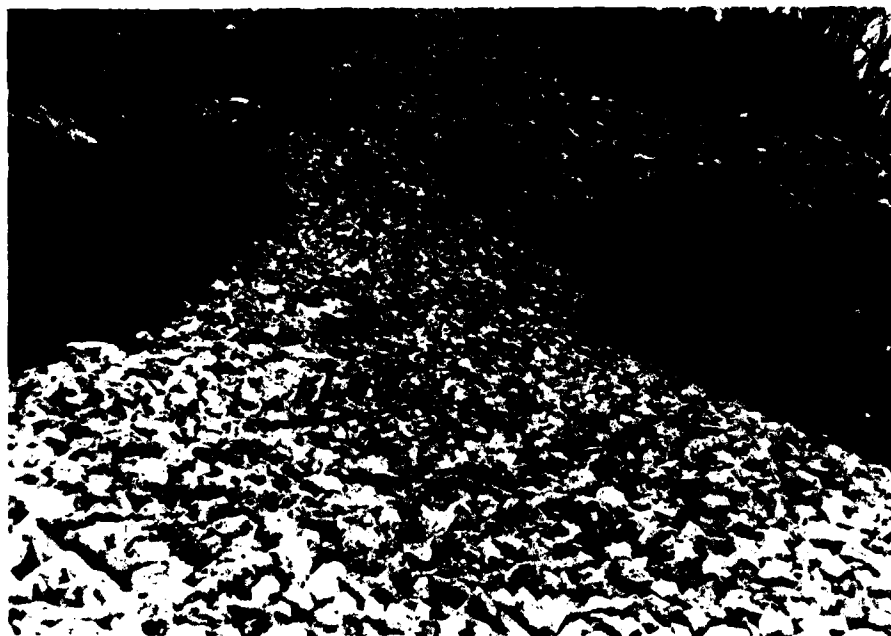
PHOTO NO. 6. Upstream end of stone protection where it ties into upper bank perpendicular to river flow.

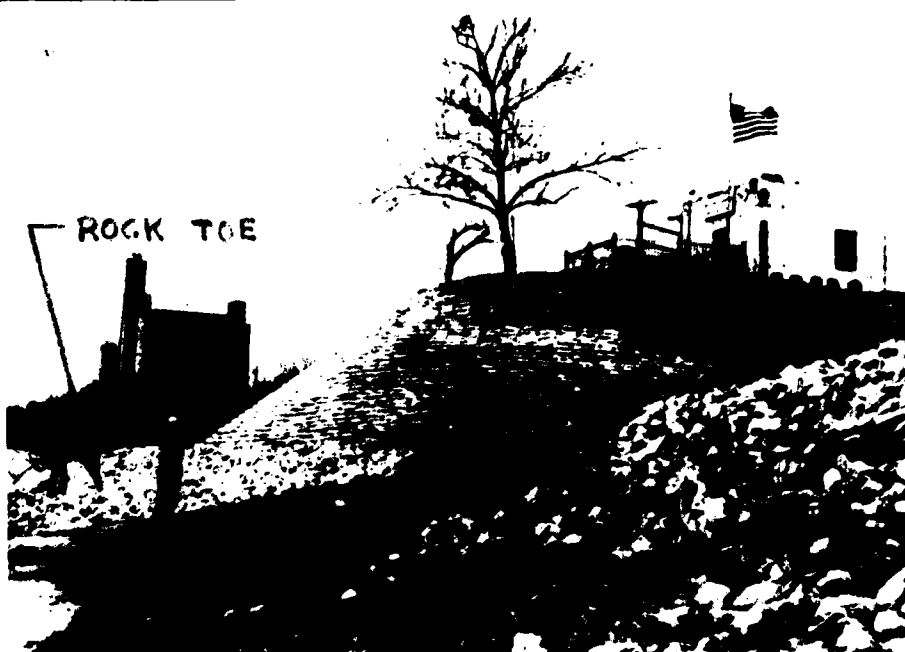
PHOTO NO. 1. Feb. 77. Project just completed. Looking downstream at sand cement bag area with riprap tow, Stations 12+50-13+50+.

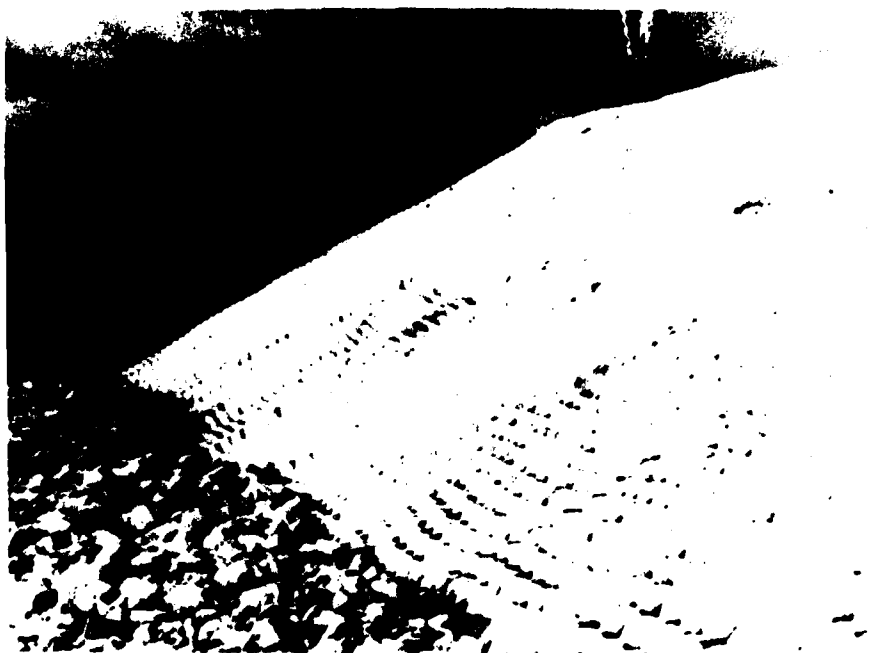
PHOTO NO. 2. Feb. 77. Project just completed. Looking downstream at fab-riform area with riprap toe, Stations 14+50-16+00.

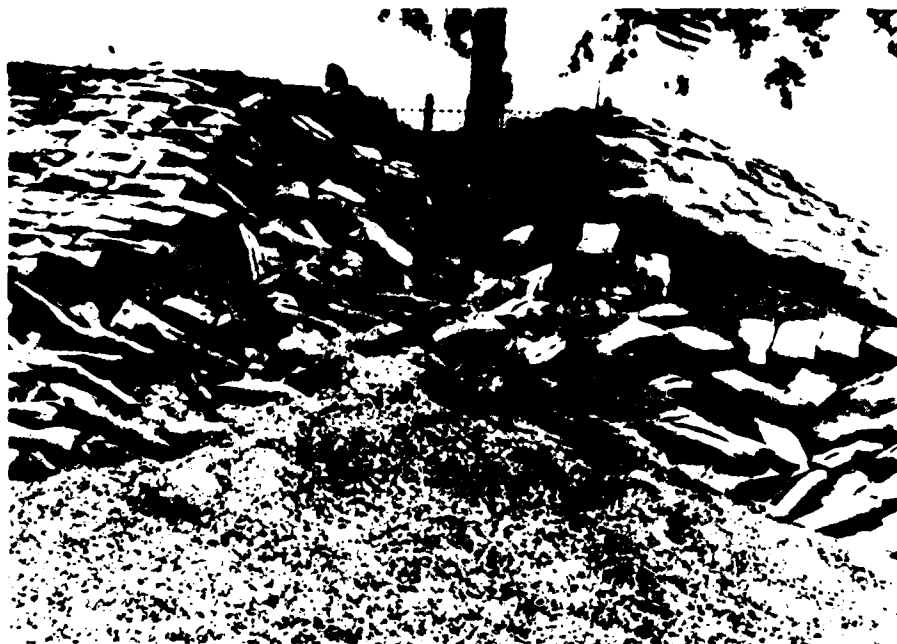
PHOTO NO. 5. May 77. Slippage of cement filled paper bags, Stations 13+50-14+00.

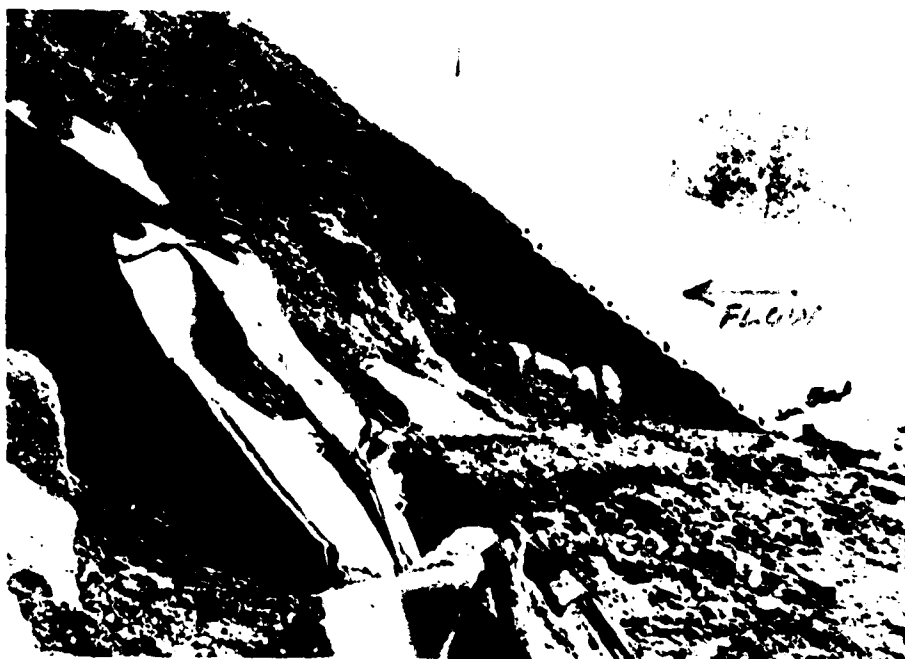
PHOTO NO. 6. May 77. Erosion just downstream of fabriform in "no-work" area (Stations 15+60-16+00). This area was later protected by rock placement.

c. The upstream and downstream ends of fabriform should be keyed into bank; or stone added, as recommended by manufacturer, since these areas, if unprotected may create localized currents and eddies causing erosion of bedding material from edges of fabriform. See photograph 6.
